Wind Power Generation Base Loop Loosening Problem

There are 20 out of 60 wind power generator has the base loop loosening problem. The generator model number is 2000. The base loop diameter is 5.5 meters. There are two generator had been shut down, and the base loop need urgent repair.

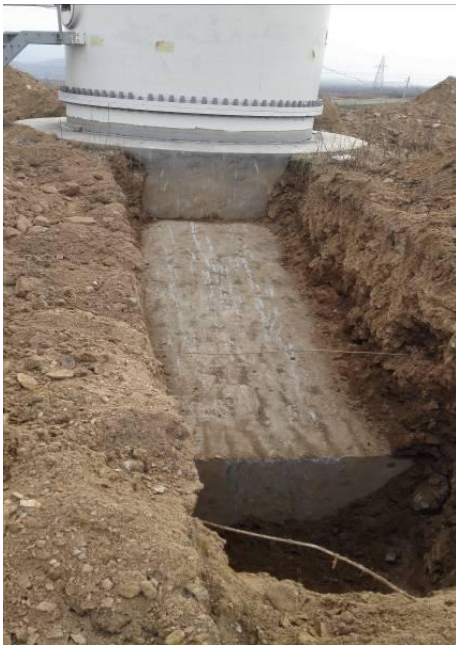
Base Picture

Base on our technicians' analysis, the base loop loosening problem has occurred because the waterproof protection between the loop and concrete in the early construction haven't been well done. That cause the intrusion of water. Due to the generator operating vibration, the rain and cement slurry has been slacken off, the gap is gradually increasing.

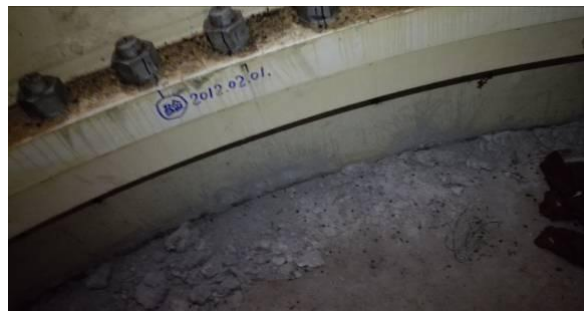
The Gap of Internal Loop ≥ 2 mm

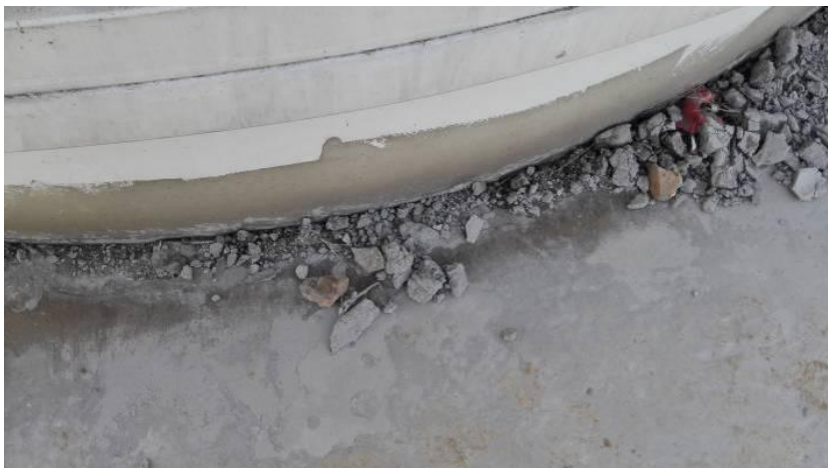
The Gap of External Loop ≥ 2 mm
