# MIBO INTERNATIONAL CORP.

## Mibo Technologies Application Archives

NO: FSLDA—0008

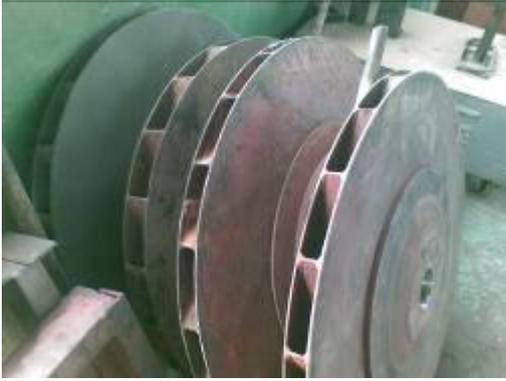
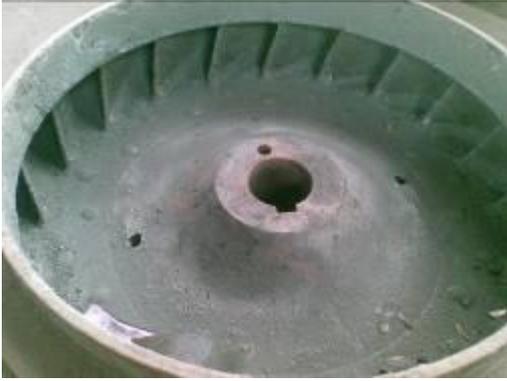
<p><b>Equipment Pictures</b></p>

<b>Equipment information</b>	<b>Industry</b>	Steel company
	<b>Repair Parts</b>	Air compressor impeller material deposition (wall)
	<b>Problem Described</b>	Steel company has a lot of fans, and those fans are high value equipments. Due to the different operation environments, the causes of fan impeller damage are different. The sintering plant turbines usually will reach a high temperature up to 200°C or even higher, which cause the material wear seriously. The gas pipeline impeller operating at about 80°C, which cause gas corrosion and dust deposition to the impeller. The dust blower operating at about 100°C, which cause dust deposition and surface pitting. Company regularly need to cleaning the material deposit, it's time consuming and require labor cost. In addition, the impeller regularly need balancing, therefore, a spare impeller is required.
	<b>Operation Environment</b>	<p><b>Impeller Size:</b> impeller diameter is 1100 mm, blade width is 55~80 mm, length is 350 mm, number of blade is 20</p> <p><b>Operating Temperature:</b> 60~70°C</p> <p><b>Flowing Media:</b> LDG (The gas is come from steel making, has high content of carbon monoxide, then through a wet dust removal process, has a certain degree of humidity)</p> <p><b>Work Flow:</b> 180 m<sup>3</sup>/min</p> <p><b>Device Speed:</b> 2976 rpm (other devices can reach 5000 rpm or higher)</p> <p><b>Parts Material:</b> Carbon steel</p> <p><b>Life Cycle:</b> the material deposit accumulate seriously in the impeller and surface. The uneven deposit on the surface usually cause the device working irregularly. The company need to shut down the device and disassemble the impeller, then cleaning the deposit with high-pressure water. It is time consuming and require labor cost.</p> <p><b>Company Requirements:</b> reduce the deposit in the impeller pipeline and surface, extend the equipment life cycle, at least six months.</p>

<p><b>Technical Requirements</b></p>	<p><b>Seeking for products and solutions to solve the aforementioned equipment problems:</b></p> <p><b>Requirements:</b></p> <ol style="list-style-type: none"><li>1、 Provide technical information of the products and solutions to solve these type of problems</li><li>2、 Provide detail technical operating processes and precautions</li><li>3、 Provide products' price list</li><li>4、 Meet the requirement of at least six months life cycle</li></ol> <p><b>Questions:</b></p> <ol style="list-style-type: none"><li>5、 How is the product's properties of surface polarity and adhesive, how to ensure adhesive?</li><li>6、 Is the material can be achieved spraying? What equipment need to use for spraying?</li></ol>
