Cleaning of Plate Heat Exchanger of Central Heating System

Case One: On-line Cleaning

Case Two: Transformer rectifier cabinet pure water cooling device plate heat exchanger cleaning

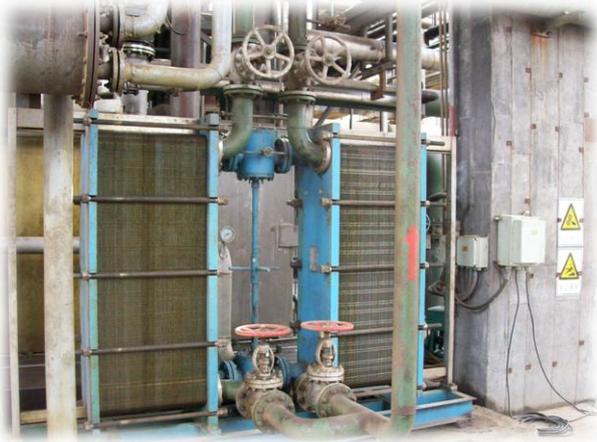
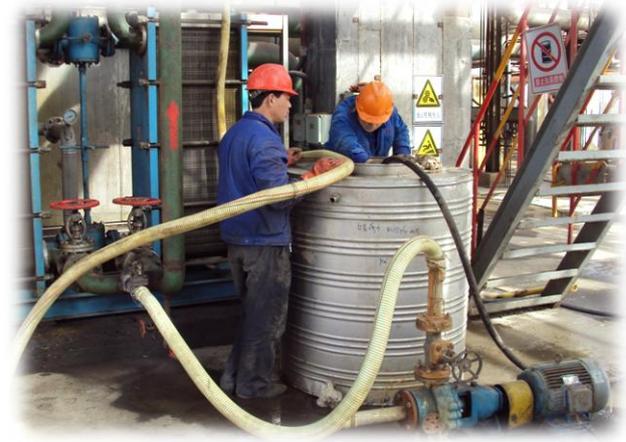
Problems: Low efficiency due to the scaling problem

Solution: 39.6 Gallon of 1st TECH Biodegradable Descaler, adding 2 to 3 times water, washed 6 hours with self circulating cleaning system.

Outcome: Water scale, rust scale, and slime have been cleaned away. Equipment operated normally. Greatly increased equipment's efficiency, and reduced the energy cost.

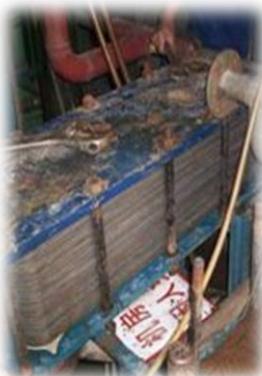
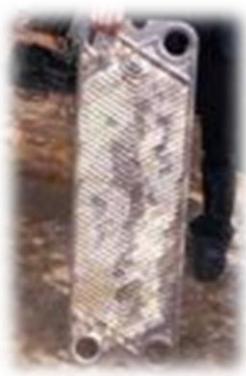
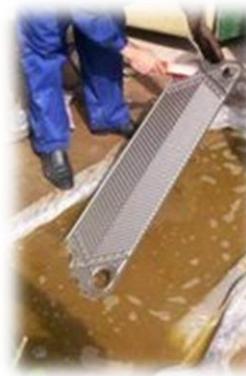
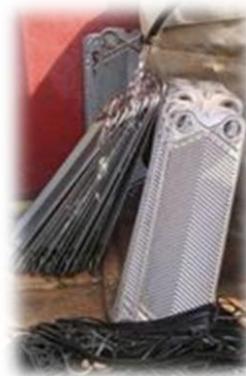
Problem: Alarm will sound when the equipment temperature goes up to 122 °F. The equipment was operation at a temperature between 114.8 °F to 118.4 °F before cleaning. Hydrochloric acid with a concentration of 30% has been used to clean it. The cleaning process produces a lot of bubbles, and it stops cleaning when bubbles reduce. This kind of cleaning brings serious corrosion problem to the equipment. The company stopped using this cleaning way after several times.

Solution: The company switch to use 1st TECH Biodegradable Descaler to circulating clean five sets of the cooling devices, and immersing clean ten plate heat exchangers.

Outcome: The temperature of the equipment decreased dramatically, which ensure the equipment operate safely and efficiently. Most of all, there was no corrosion effect.
